## INTRODUCTION

Early on the 4<sup>th</sup> of August 2014, an embankment breach occurred at the Mount Polley Mine Tailings Storage Facility (TSF) located in British Columbia, Canada. The cause of the breach, which released millions of cubic metres of tailings slurry and supernatant water (Brown et al., 2016) from the TSF into Polley Lake, Hazeltime Creek, and Quesnel Lake, was subsequently examined by an Independent Expert Engineering Investigation and Review Panel (the Panel). The Panel reported on its findings (Morgenstern et al., 2015) on the 30<sup>th</sup> of January 2015, concluding that the dominant reason for the breach was embankment foundation soil failing under undrained conditions due to stresses imposed by the embankment construction.

# GDS CASE STUDY: MOUNT POLLEY MINE TAILINGS STORAGE FACILITY EMBANKMENT BREACH

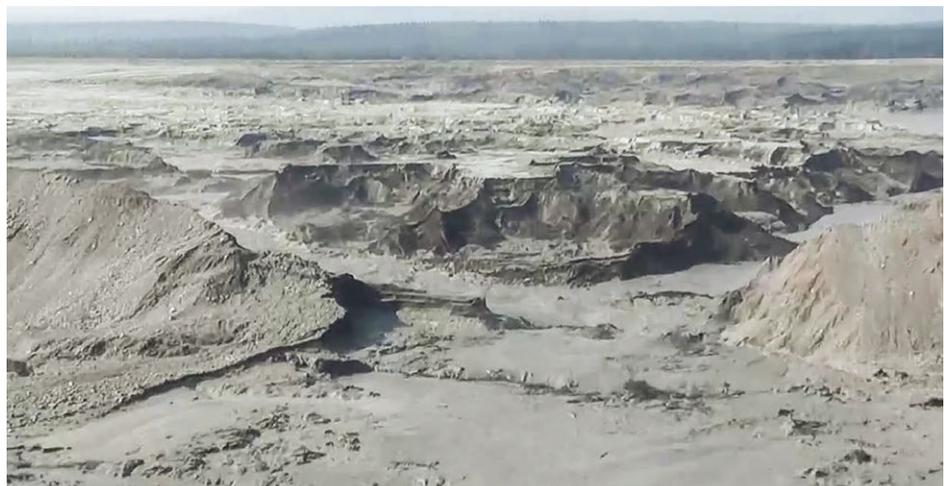
Figure 1: Photo of the Mount Polley Mine Tailings Storage Facility breach, looking upstream.

Surface investigations provided direct evidence that shear failure of foundation soil beneath the Embankment was the primary cause of the breach. Subsurface investigations then inferred the location of the shear failure zone to be within the Upper GLU unit, at an elevation approximately 10 m below the Embankment base.

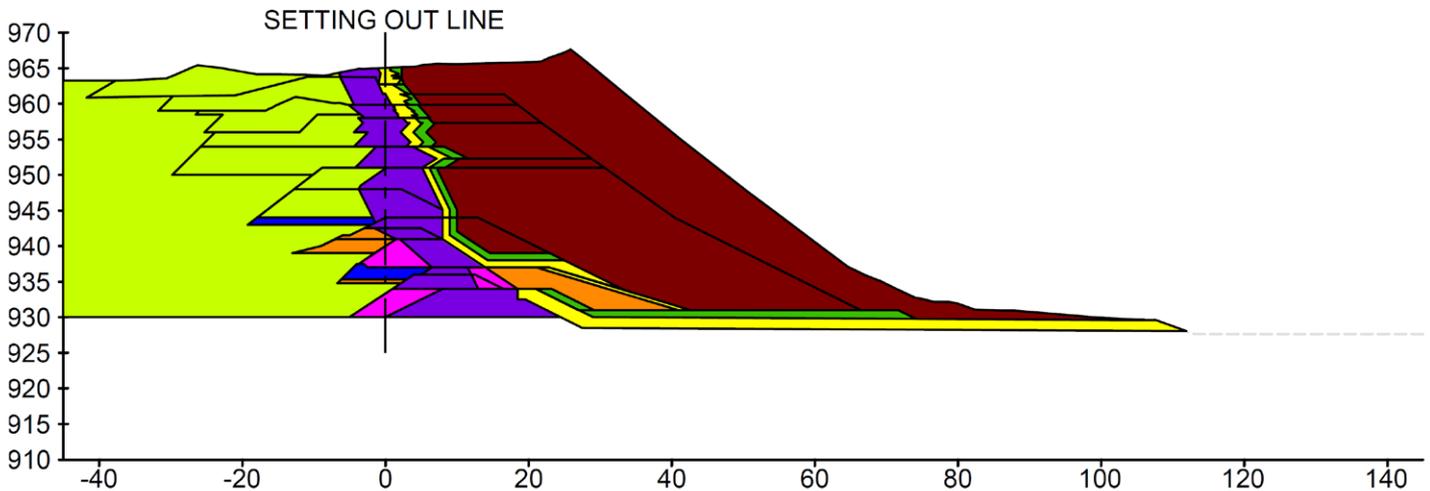
The Embankment design consisted of an impervious core, with filter, transition, and rockfill zones on the downstream side of core. Upstream of the core, a fill zone was to consist of rockfill and/or tailings. The Embankment was also initially designed to be constructed using a modified centreline configuration however, a number of Embankment raises ultimately utilised an upstream-style construction configuration.

Figure 2: Schematic section of the Embankment prior to failure occurring.

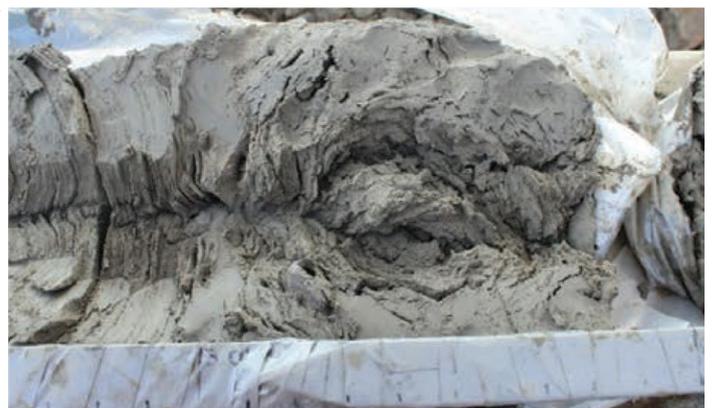
Figure 3: Photo of Upper GLU soil sampled from within the breach area, showing contorted and folded laminations.

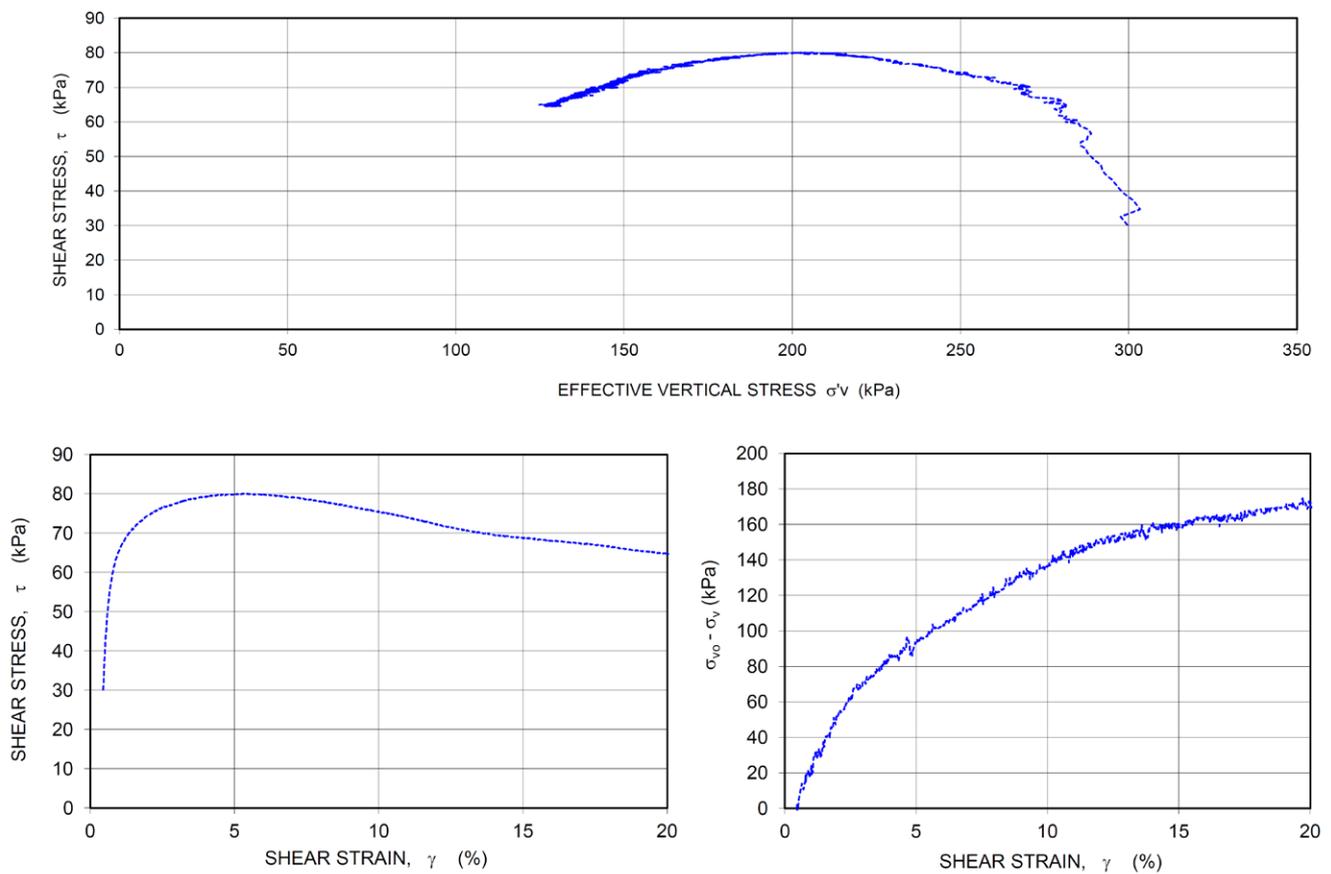
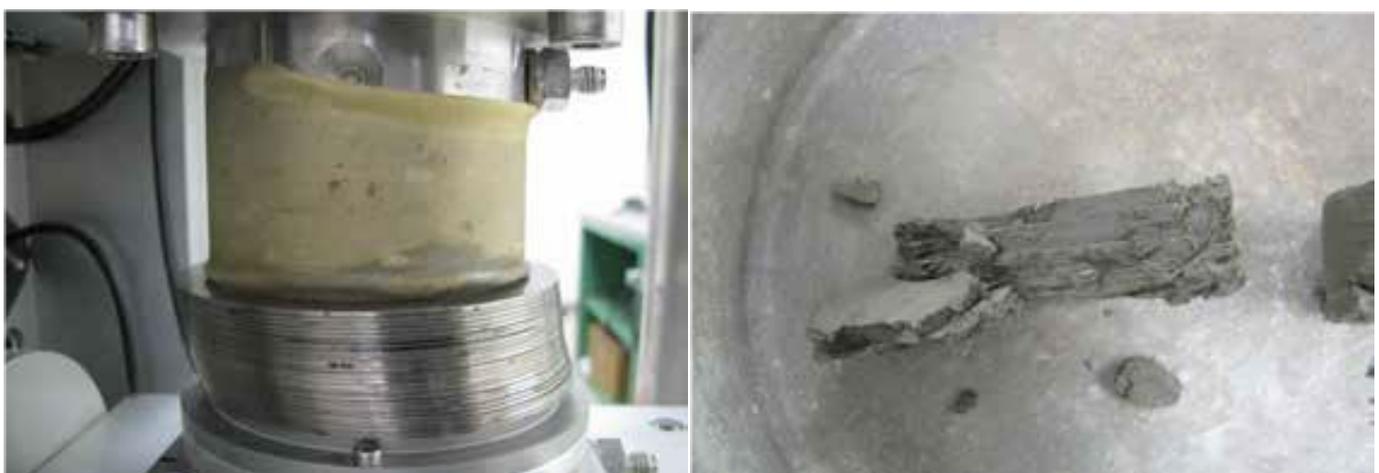
Data gained from the direct simple shear tests produced estimations of peak undrained strength ratios (i.e., peak shear stress divided by vertical effective consolidation stress) in the range of 0.20 to 0.28, depending on the consolidation conditions. In addition, the test specimens generally demonstrated strain softening behaviour (i.e., a reduction in shear stress) once the soil was strained beyond the peak shear stress.

Figure 6: Direct simple shear response and photos of an Upper GLU soil specimen tested under constant volume conditions within a GDS Electromechanical Dynamic Cyclic Simple Shear (EMDCSS) device.

- The direct simple shear testing also highlighted the strain softening tendency of the Upper GLU soils. This demonstrated that the resistance of the soil to applied loading would decrease as shear deformations progressed, and helped to explain why the Embankment failure occurred in a sudden manner.

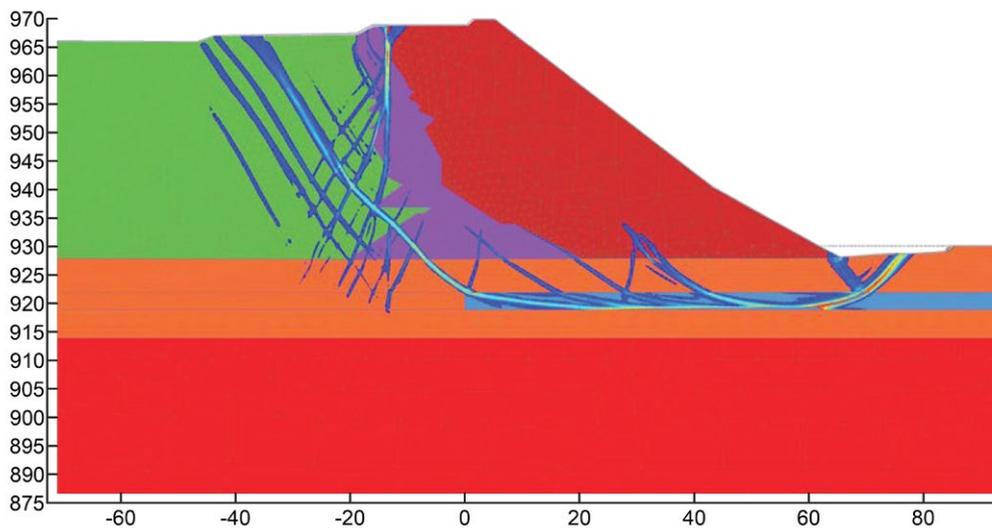
- The direct simple shear testing provided the Panel with undrained strength parameters for the Upper GLU soils that were critical to the investigation. These parameters, subsequently adopted within limit equilibrium and deformation analyses that examined Embankment stability, helped the Panel to conclude that undrained failure of the Upper GLU deposit was the specific mechanism that caused the breach to occur.

Figure 9: 2D PLAXIS analysis conducted by the Panel, showing the Embankment deformation locations estimated at failure.
