USER: PETERIS SKELS, RESEARCHER, KASPARS BONDARS D.Sc., LEADING RESEARCHER, RIGA TECHNICAL UNIVERSITY

THE PROBLEM

SITE INVESTIGATION

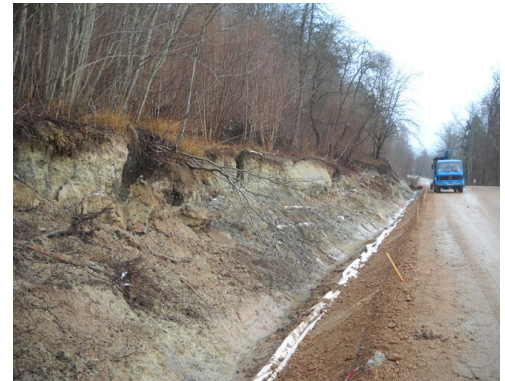
Figure 1. Soil embankment next to the P130 motorway.

In 2014 after a period of persistent rainfall, a landslide developed during the construction of the P130 motorway, in the upper part of the Abava river valley between Sabile and Kandava. The soil samples taken for testing came from the bottom of the cracks which,

were approximately 2m deep and 2m wide. Physical and laboratory tests were carried out on these samples.

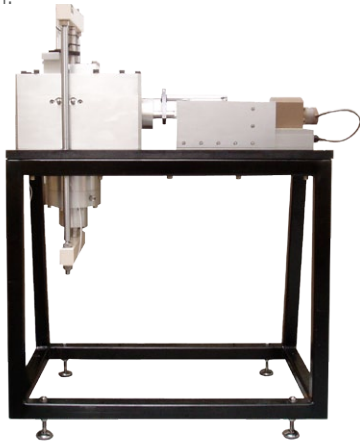
Figure 2: GDS Instruments Back Pressured Shear Box

The BPS is based on a standard direct shear device, modified to allow the measurement of pore water pressure and control of back pressure. The apparatus can function as both a conventional direct shear and back pressured shear machine (Carey, 2011). The testing was performed in two different set-ups. Firstly, the soil strength properties were tested according to LVS EN ISO/TS 17892-10, but measuring pore water pressure to get effective parameters (saturation, consolidation and shearing). Secondly, the pore water inflation mechanism was tested when desired normal stress and shear stress values were reached (based on the 'safe' side of the Mohr-Coulomb failure plain), they were kept constant. The pore water pressure was raised linearly by 2kPa/hour. The soil sample was therefore under pore pressure inflation and sheared under constant normal stress and shear stress as and when the effective stress reduced enough to allow shearing to occur.

testing according to LVS EN ISO/TS 17892-10. Soil samples were trimmed out of the sample block to precisely 100x100x45mm and fitted into the shear box. Testing was carried out using the unique back-pressured shear box (BPS) apparatus developed by the University of Durham and constructed by GDS Instruments. The BPS provided the opportunity to carry out direct shear testing on soil samples while controlling the pore water pressure of the specimen.

2. The GDS back Pressure Shearbox (BPS) allows the effective shear strength peak and residual parameters by measuring pore water pressure to be determined.

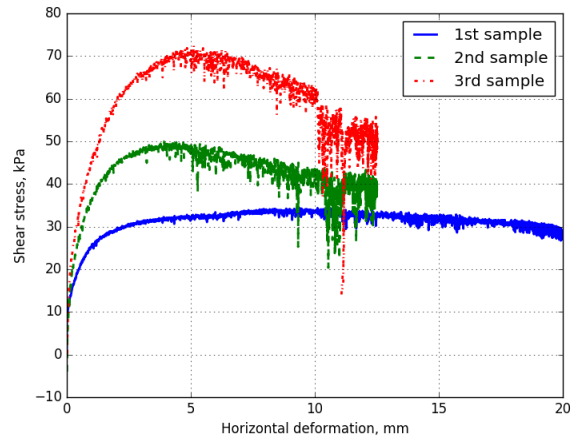
Soil shear strength parameters were determined at three different consolidation pressures (normal stresses), chosen in range between 25kPa and 150kPa, assuming that shearing plane was relatively shallow, about 2m deep at most (Figure 3).

Figure 3. Shear stress (strength) as a function of shear deformations.

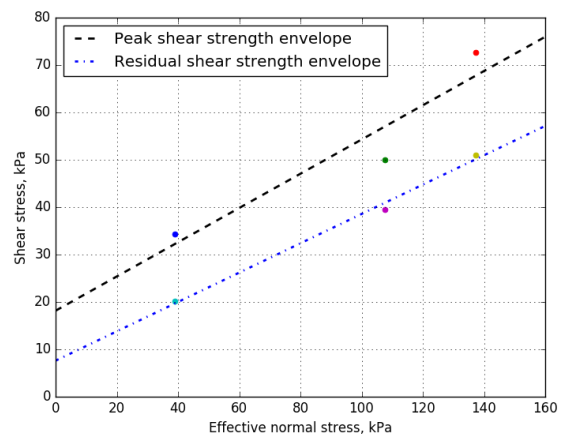
Mohr-Coulomb failure criteria was tested on three soil samples for peak and residual parameters, these are shown in Figure 4. The shear strength (peak and residual) of tested soil specimens at particular effective normal stress are as follows:

- For the 1st specimen at normal stress of 39.07 kPa
 $\tau_1 = 34.38kPa, \tau_{residual_1} = 20.12kPa$
- For the 2nd specimen at normal stress of 107.61 kPa
 $\tau_2 = 50.05kPa, \tau_{residual_2} = 39.54kPa$
- For the 3rd specimen at normal stress of 137.27 kPa
 $\tau_1 = 72.62kPa, \tau_{residual_3} = 51.08kPa$

Figure 4. Shear stress (strength) as a function of effective normal stress.

The effective peak strength parameters are $\phi' = 19.86^\circ$; $c' = 18.15kPa$ and the effective residual strength parameters are $\phi'_{residual} = 17.20^\circ$; $c'_{residual} = 7.61kPa$.

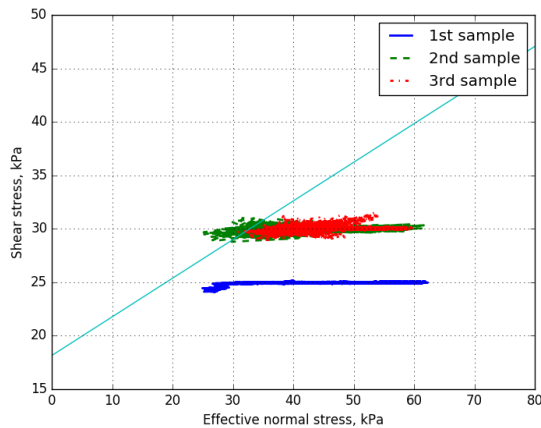
Pore water pressure inflation mechanism was tested. Four separate tests were conducted assuming point at the "safe"

side of the Mohr-Coulomb failure plain and raising pore water pressure at constant rate until shearing. Three samples were tested at the same constant shear stress of 30kPa and one sample at 25kPa as shown on the Figure 5.

Figure 5. Shear stress as a function of effective normal stress; pore pressure inflation testing.

This set-up acts as a physical model of real condition, where in slopes pore water pressure is rising due to water infiltration or exfiltration. These initial tests have proved that soil will shear close to the peak shear strength envelope, as expected (Fig. 5).

3. Pore water inflation testing allows the application of the stress path (Fig. 5), which pretends real case situation of pore water triggered landslide.

4. Pore water inflation testing has shown that soil will shear close to the peak shear strength envelope, it is possible to evaluate shear strength parameters by testing different stress path starting from the “safe” side of envelope, and by changing the effective normal stress by pore water pressure control.
