GDS CASE STUDY: CADIA VALLEY OPERATIONS NORTHERN TAILINGS STORAGE FACILITY EMBANKMENT SLUMP

INTRODUCTION

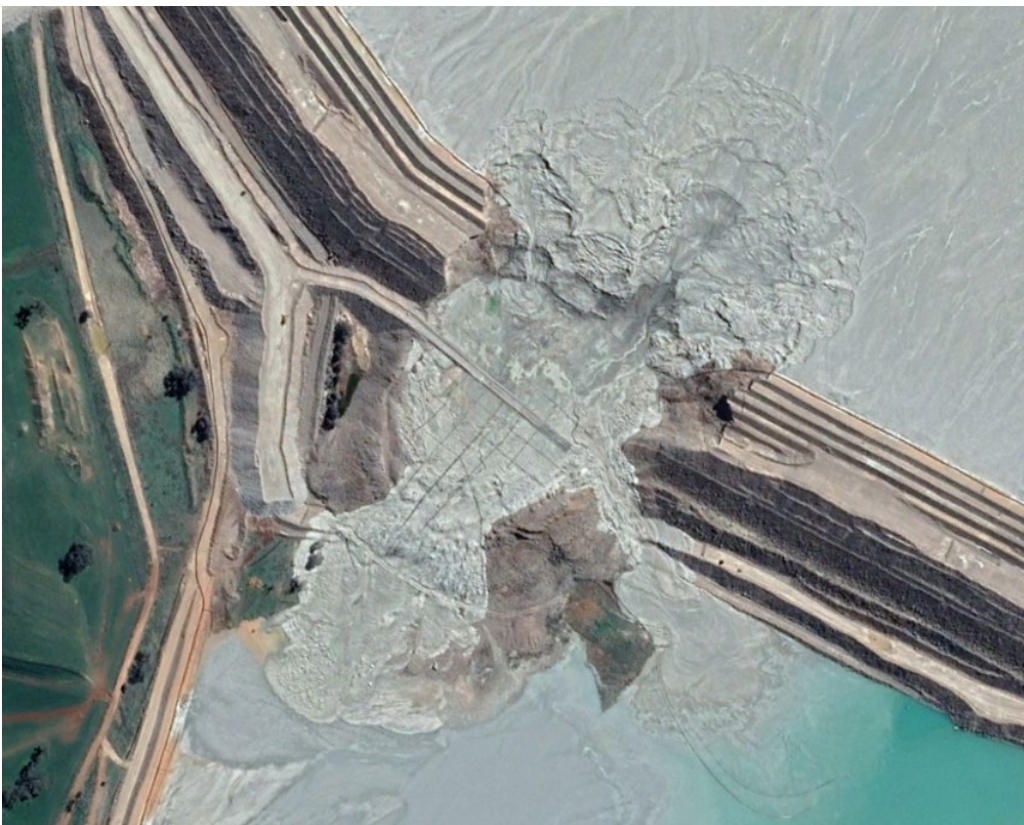
Figure 1: Aerial view of the Cadia NTSF southern embankment slump location as of the 13th of September 2018.

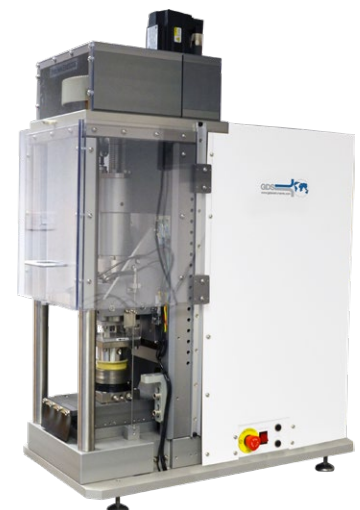
Figure 4: The GDS Electromechanical Dynamic Cyclic Simple Shear (EMDCSS) device.

Golder conducted 24 constant volume direct simple shear tests on a number of tailings gradations and FRV Unit A specimens as part of the advanced laboratory testing programme. This testing was undertaken using a GDS Electromechanical Dynamic Cyclic Simple Shear (EMDCSS) device, which enables a constant specimen volume to be maintained during shearing (monotonic and/or cyclic) via a low compliance DSS device design, active height control, and physical lateral restraint via a stack of low-friction retaining rings (alternatively, a wire-reinforced rubber membrane may also be used).

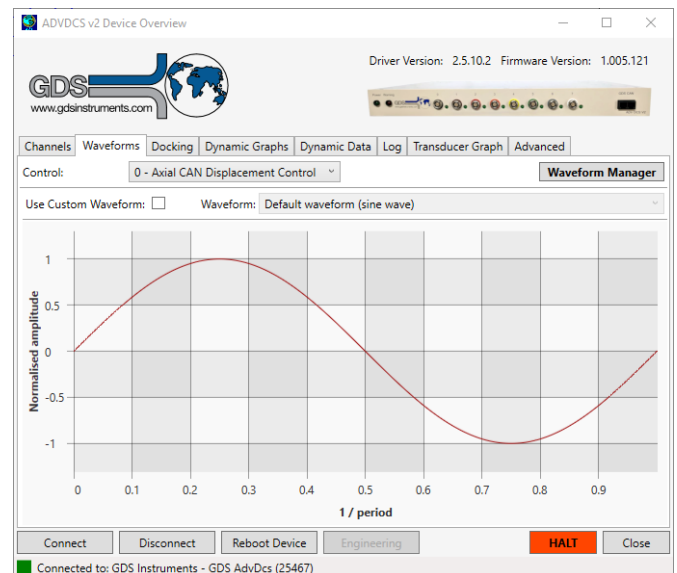
Figure 5: GDSLab software interface for defining custom cyclic loadings when performing tests within a GDS EMDCSS.

test specimens at a frequency of 1 Hz, while two specimens had custom cyclic loadings applied that simulated the ground motions of the two low-magnitude earthquakes experienced on the 8th of March 2018. Figure 5 displays the GDSLab software interface for users to define custom cyclic loadings when performing tests within a GDS EMDCSS.

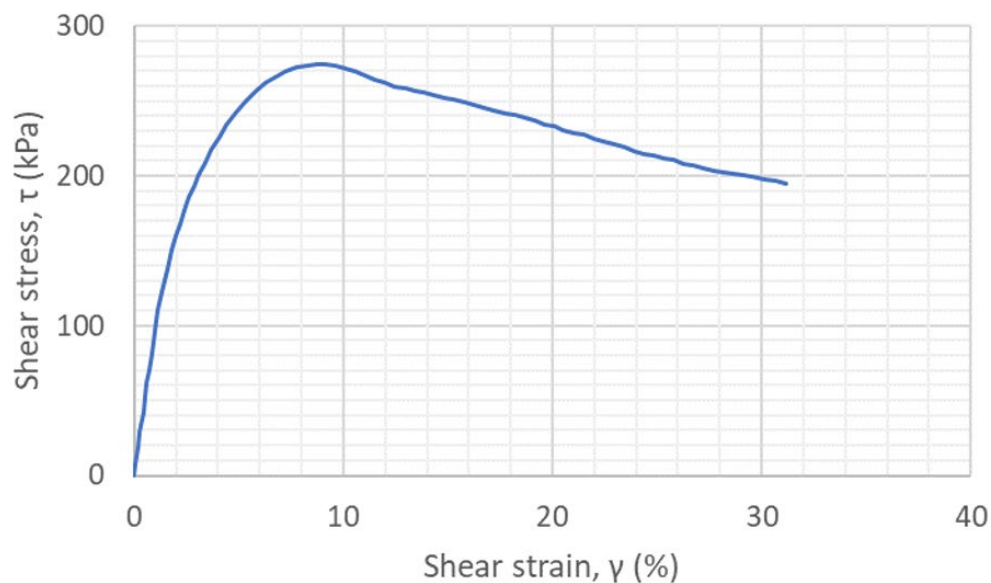
Figure 6: Stress-strain response of a FRV Unit A specimen tested under constant volume monotonic DSS conditions within the GDS EMDCSS.

estimations of peak undrained strength ratios (i.e., peak shear stress divided by vertical effective consolidation stress) in the range of 0.26 to 0.56, depending on the consolidation stress and tube or block sampling location. Importantly, the specimens generally displayed strain-weakening behaviour (i.e.,

a reduction in shear stress) once the soil was strained beyond the peak shear stress, highlighting the brittle response of the FRV Unit A material. The post-peak average loss in strength was approximately 25 % (with a range of strength loss of approximately zero to 40 % loss).

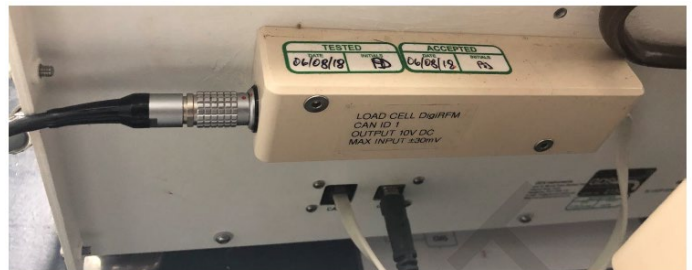
Figure 9: GDS DigiRFM installed within a GDS TAS.

specimen, even when a specimen is rapidly collapsing (i.e., experiencing rapid axial straining). Golder used two triaxial configurations to achieve this criterion: One in which dead-weights were manually placed on a loading hanger, and another in which a GDS DigiRFM was installed within the GDS TAS. The DigiRFM introduces a rapid, direct feedback loop between the triaxial load cell and load frame, enabling the load frame to axially compress test specimens at over 90 mm per minute, maintaining the targeted deviator stress. Users interested in upgrading their GDSTAS to include a DigiRFM should contact GDS directly.

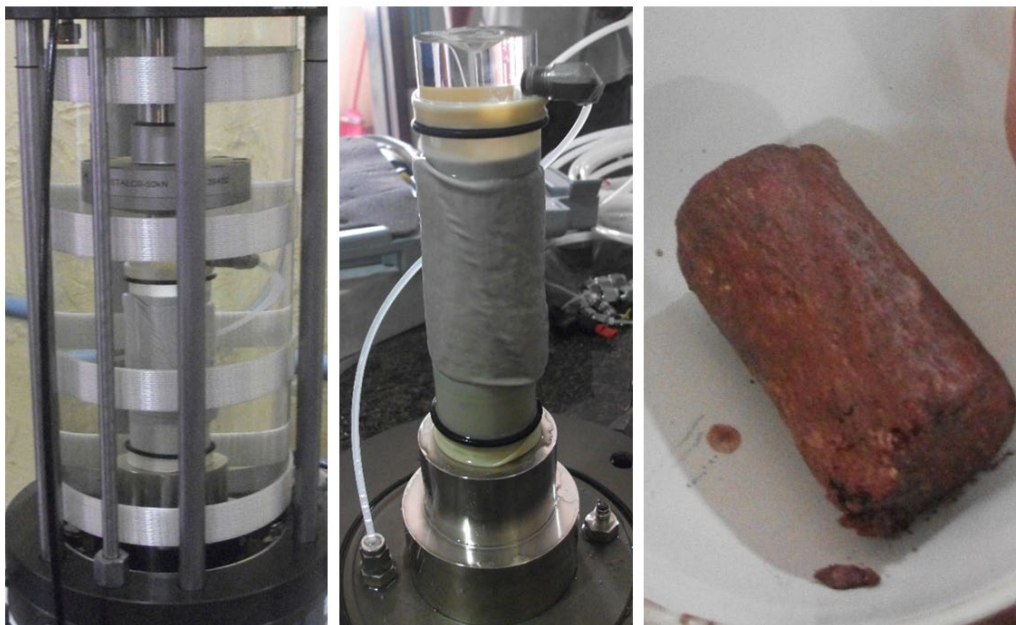
Figure 12: Photos of an isotropically-consolidated fine-grained soil specimen tested under undrained monotonic strain-controlled compression conditions within a GDSTAS. This test was in no way related to the Cadia NTSF embankment slump investigation, and is shown for illustrative purposes only.

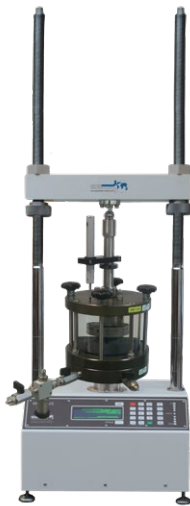
Figure 13: The GDS Constant Rate of Strain system (GDSCRS).

Golder conducted two constant rate of strain (CRS) tests on FRV Unit A specimens as part of the advanced laboratory testing programme. This testing was undertaken using a GDS Constant Rate of Strain (GDSCRS) system, in which an advanced velocity-controlled load frame is used to apply vertical stress to a laterally-confined, back-pressured test specimen. Back pressure is supplied via a GDS pressure/volume controller.
